Land Subsidence Rate in the McMullen Valley, La Paz and Maricopa Counties
Based on Radarsat-2 Satellite Interferometric Synthetic Aperture Radar (InSAR) Data
Time Period of Analysis: 1.0 Years 03/04/2021 To 04/16/2022

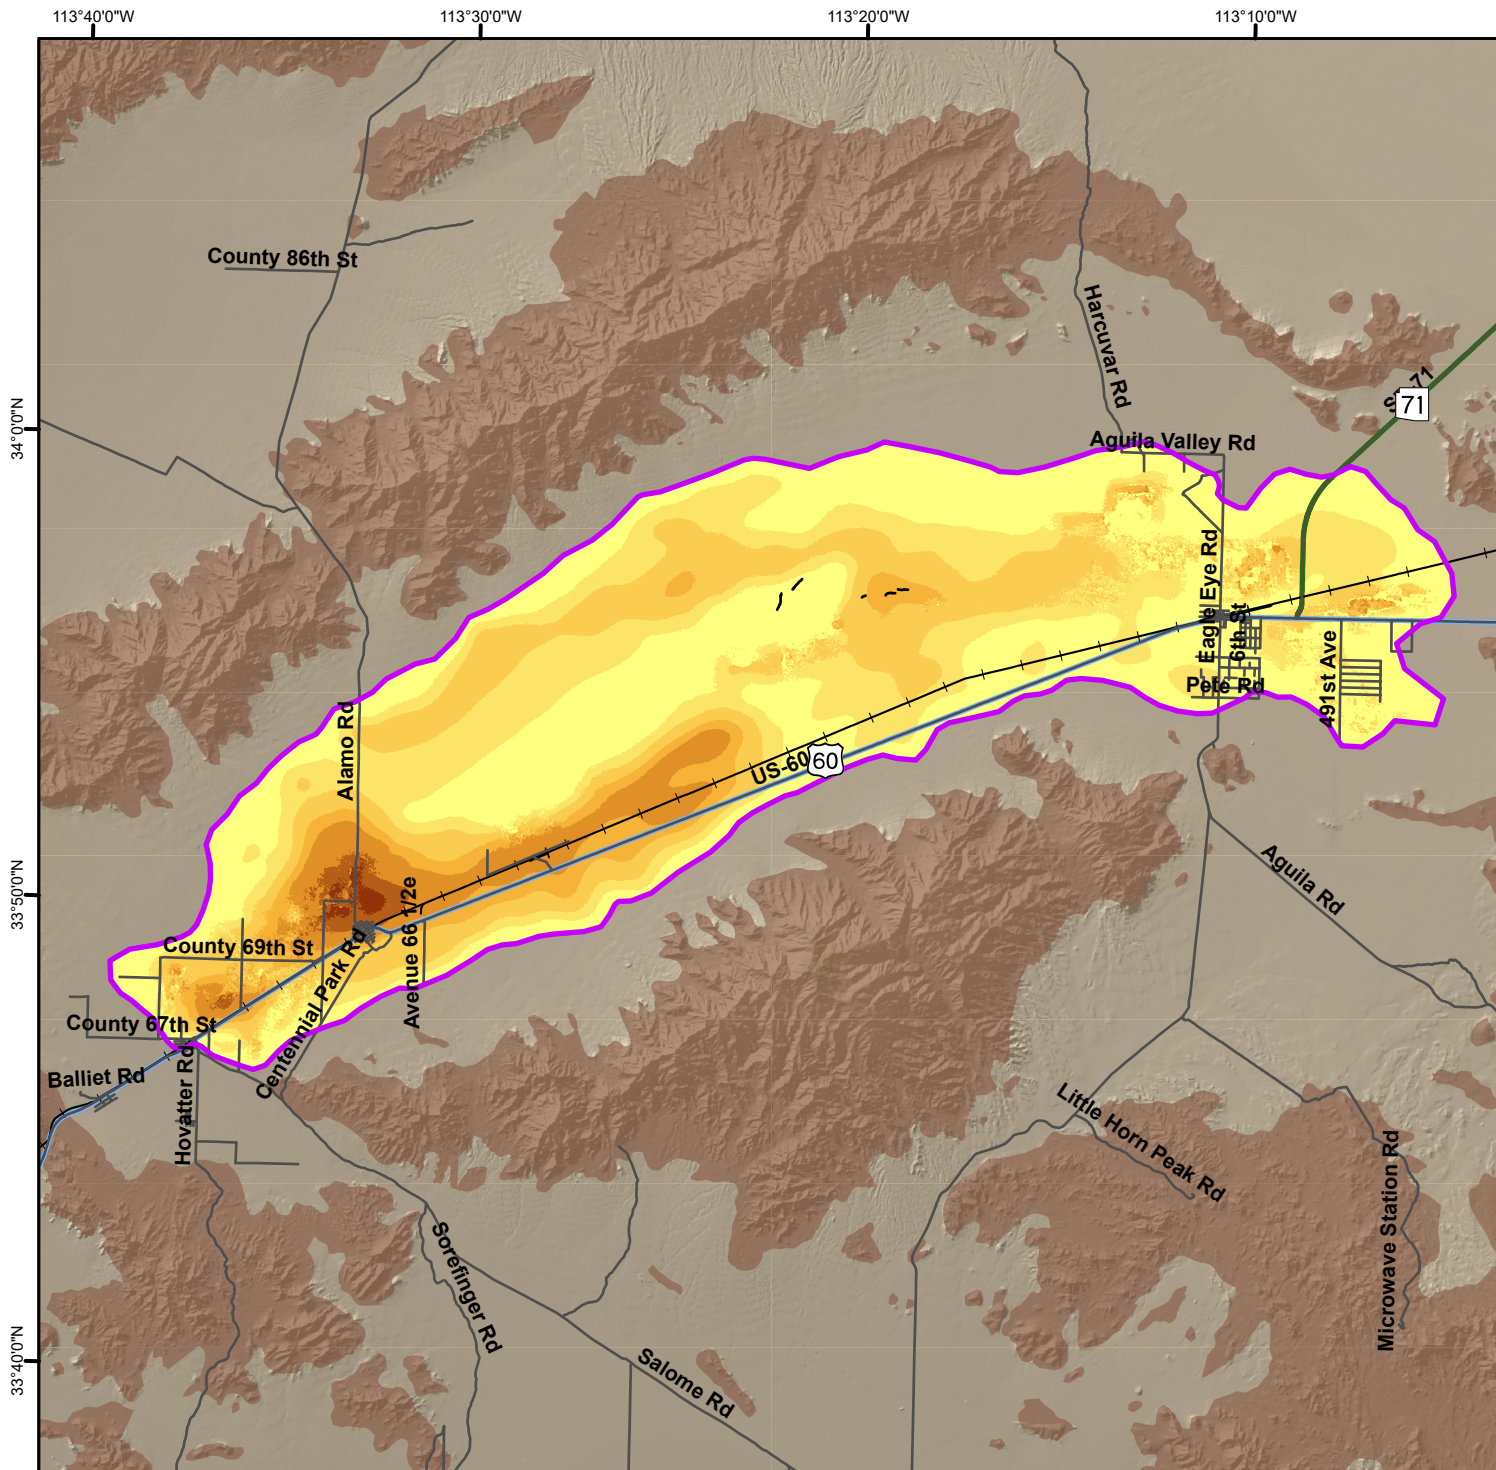
Decorrelation (white areas) are areas where the phase of the received satellite signal changed between satellite passes, causing the data to be unusable. This occurs in areas where the land surface has been disturbed (i.e. bodies of water, snow, agriculture areas, areas of development, etc).
